Manhole Inspection Summary

Manhole # **S13MM_008MH**

Insp Date: **9/4/07 3:32 PM**

Location Address: **POPLAR GROVE DR ALLEY**

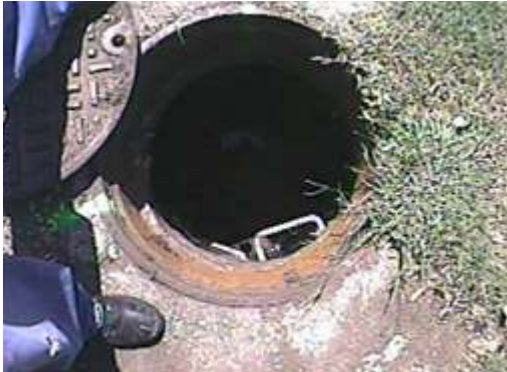
Top View

FRAME OFFSET

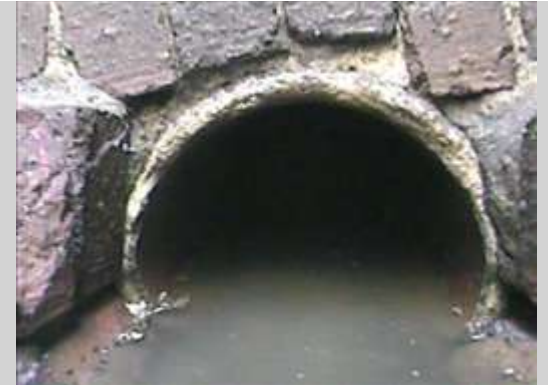
12 O'Clock Outflow

8 in. Circular Gravity Sewer
Pipe Out @ 12 O'Clock

Pipe Height: (in.) Direct
Pipe Material: **Clay** ☐ Pipe Lined
Invert Depth: **6.96** (ft.) Flow Characteristics: **Slow**
Deposits: ☒ None ☐ Mud ☐ Sludge ☐ Debris ☐ Grease
Silt Depth: (in.) Deposits Extent:
Infiltration: **None** Pipe Seal Cond: **Sound**

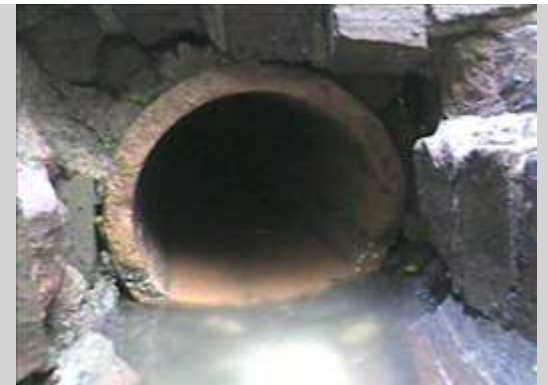
3 O'Clock Inflow

8 in. Circular Gravity Sewer
Pipe In @ 3 O'Clock

Pipe Height: (in.) Direct
Pipe Material: **Clay** ☐ Pipe Lined
Invert Depth: **7.02** (ft.) Flow Characteristics: **Slow**
Deposits: ☒ None ☐ Mud ☐ Sludge ☐ Debris ☐ Grease
Silt Depth: (in.) Deposits Extent:
Infiltration: **None** Pipe Seal Cond: **Sound**

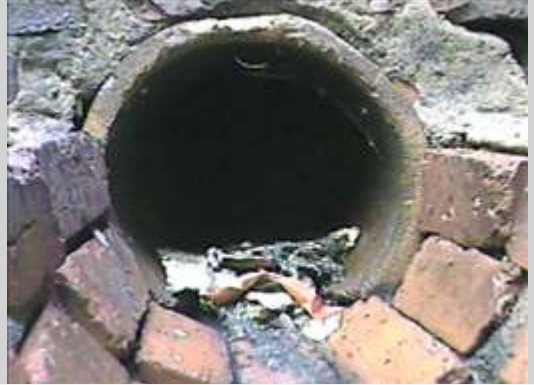
9 O'Clock Inflow

8 in. Circular Gravity Sewer

Pipe In @ 9 O'Clock

Infiltration: **None** Pipe Seal Cond: **Broken**
